**Instruction for installing the upgrade-(k)it V2.96**  
**STANDARD C520, C528, C620, C628** protection charge 2 Euro

# **Installation of upgrade-kit STANDARD C528 / C520**

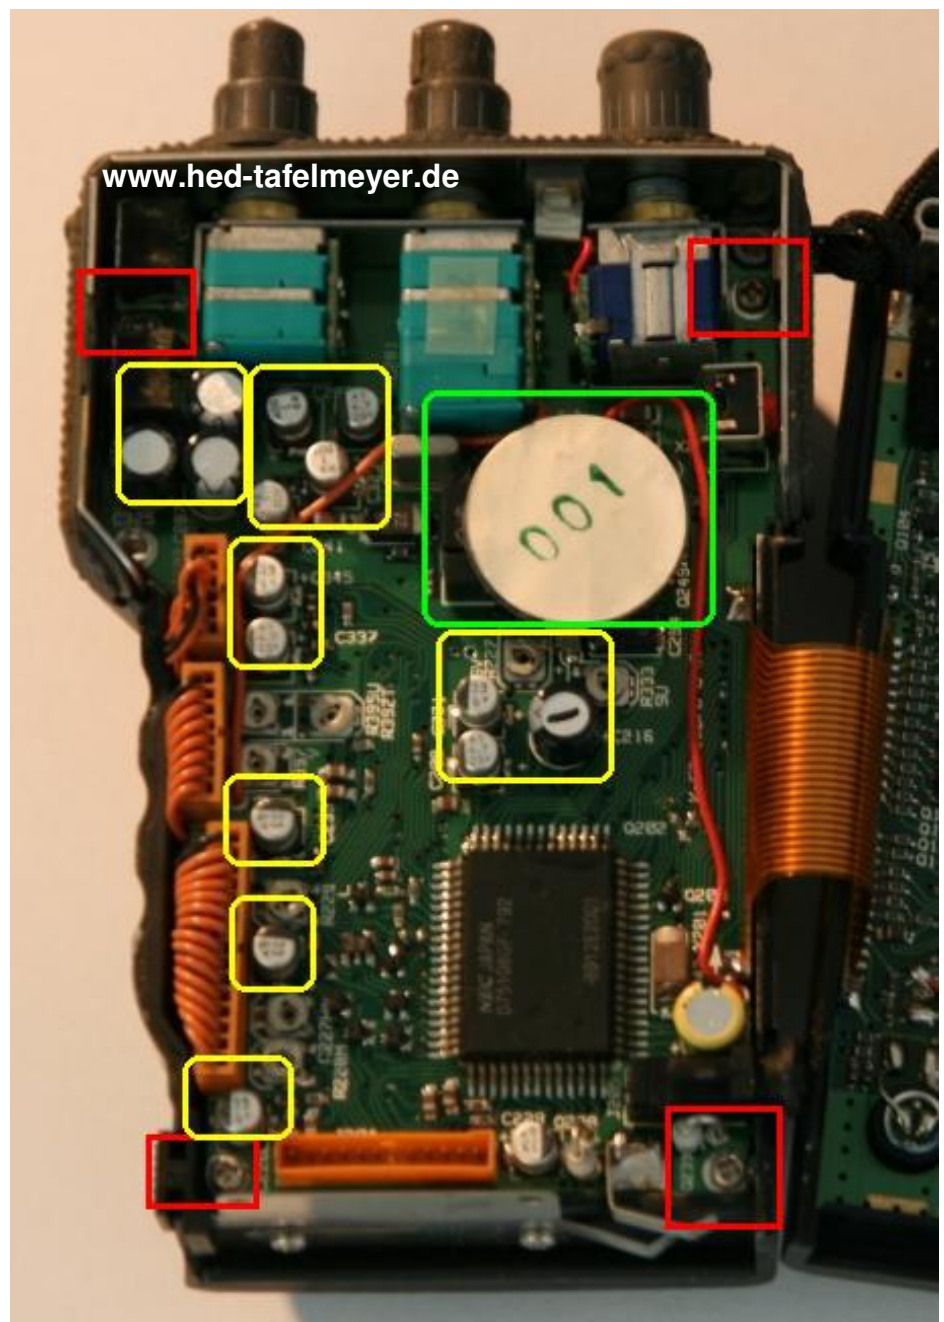
**Picture  $\mu$ PC-pcb**  $\Rightarrow$

On the left side ( $\mu$ PC und Audio) you can see 4 silver-screws (red marked). Please take them out carefully with a fitting screwdriver.

red = screws which have to be taken out

yellow = damaged capacitors

green = Backup-Batterie

Sometimes there is a small pcb on the  $\mu$ PC. Congrats! This is the CTCSS-Unit! Seldom to get! Please take it out carefully.

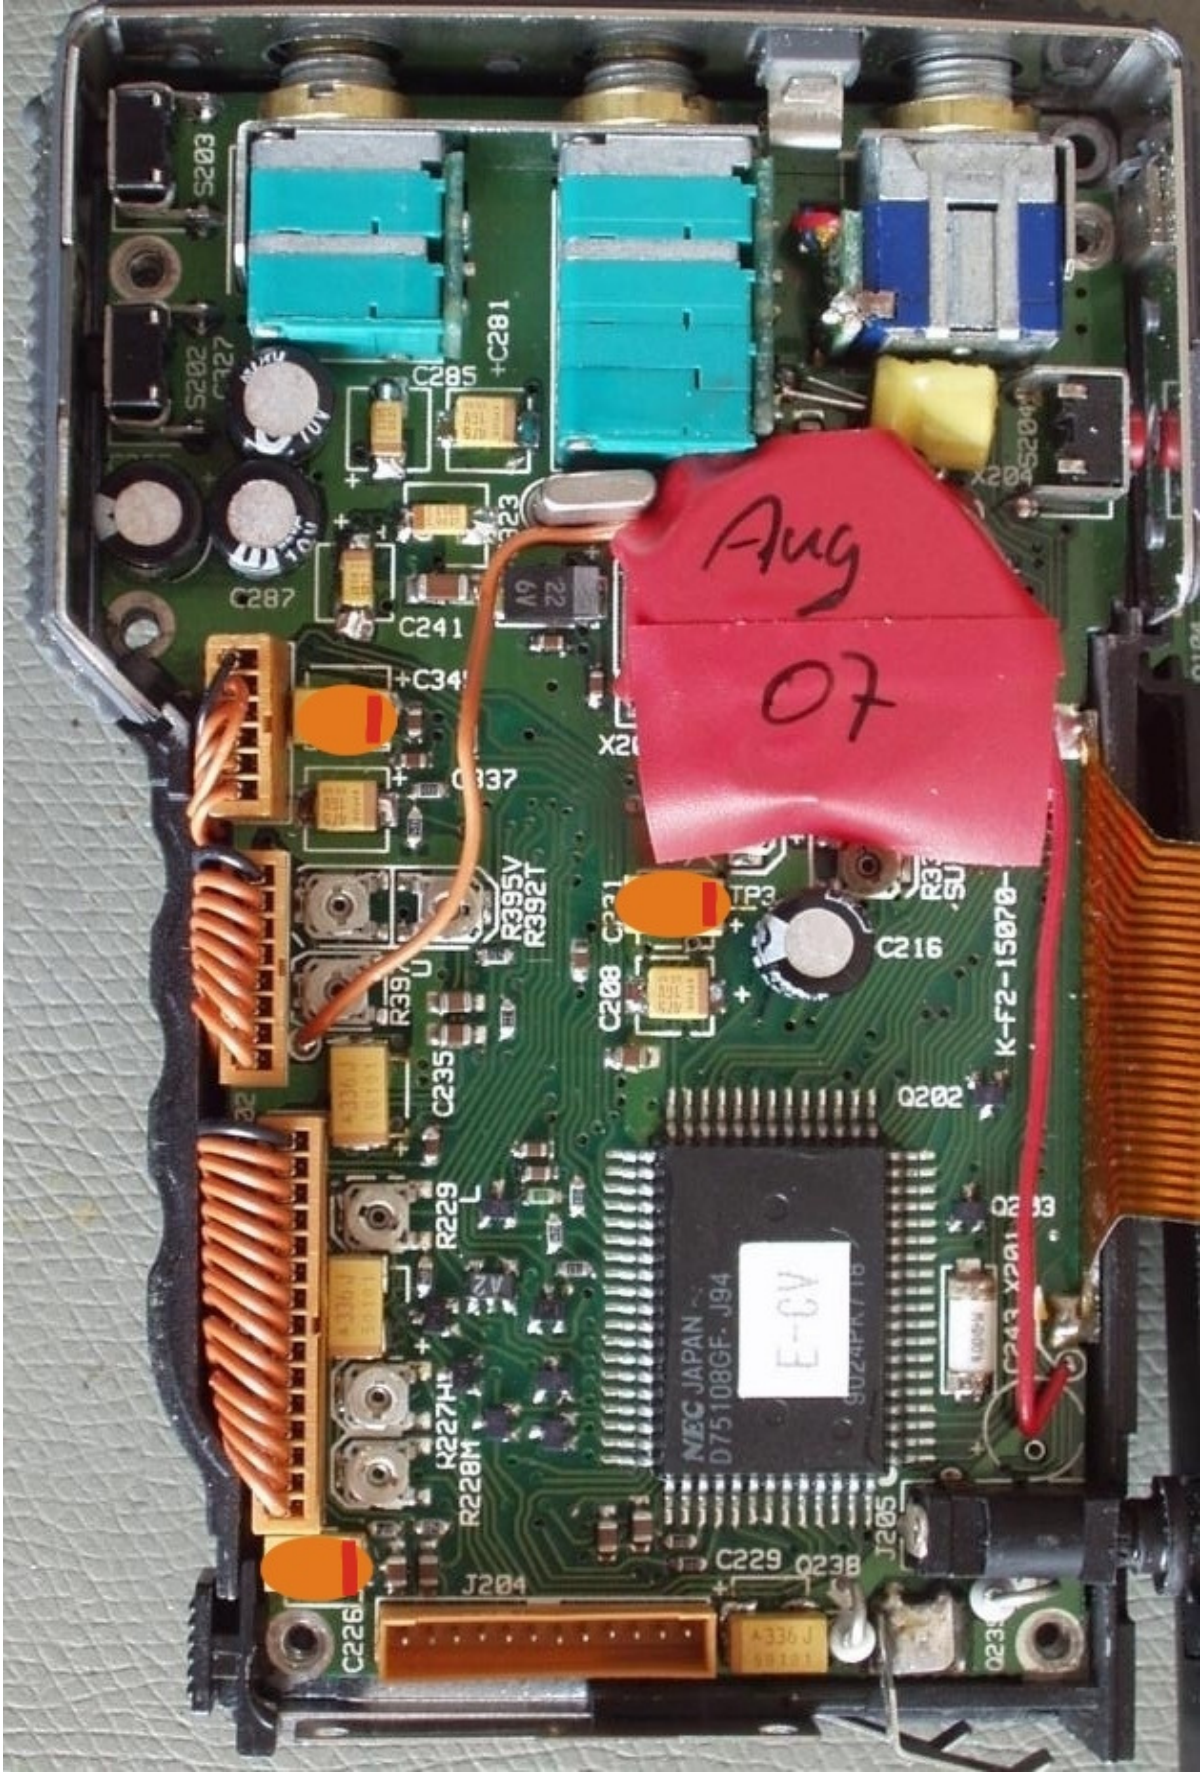
SMD-Cs after installation

- 4,7 $\mu$ F:           **C281 (not on C620/C628), C337, C208**
- 2,2 $\mu$ F:           **only in C620 and C628**
- 1 $\mu$ F:             C241, C285, C323,
- 33 $\mu$ F SMD       C235, C239, C229
- 33 $\mu$ F wired      C345, C231, C226

For the remaining 3 caps C235, C239 and C229 SMD-parts will be installed. DF2YB gave me a tip for installing them easily: Just flip the 3 caps on 90°. That makes installation quite comfortable.

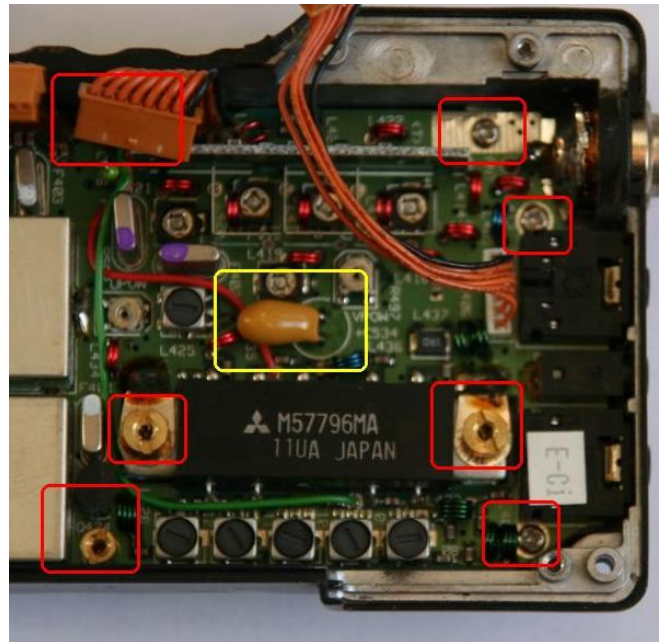
Picture 3

Please make loose the red marked screws.

In picture 3 and 4 you see the yellow marked capacitors already renewed.

At first you have to bow the wires of the new 10 $\mu$ F capacitor down for 90° before soldering.

Marked side looks down to the pcb, marking shows to power amplifier.

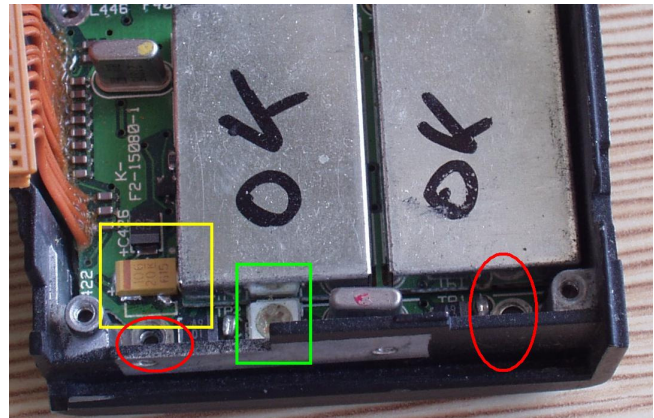
Picture 4

Now the small 10 $\mu$ F SMD-capacitor has to be renewed. It is located between a shield box and the biggest orange connector. At first heat up both sides carefully then lift it off and out. After this the area must be cleaned softly. The pads should be resoldered a little.

Ok, now you can put in the new 10 $\mu$ F-SMD cap.
